How to identify condition

WAR MEMORIALS ONLINE

War memorials in 'Fair' and 'Poor' condition

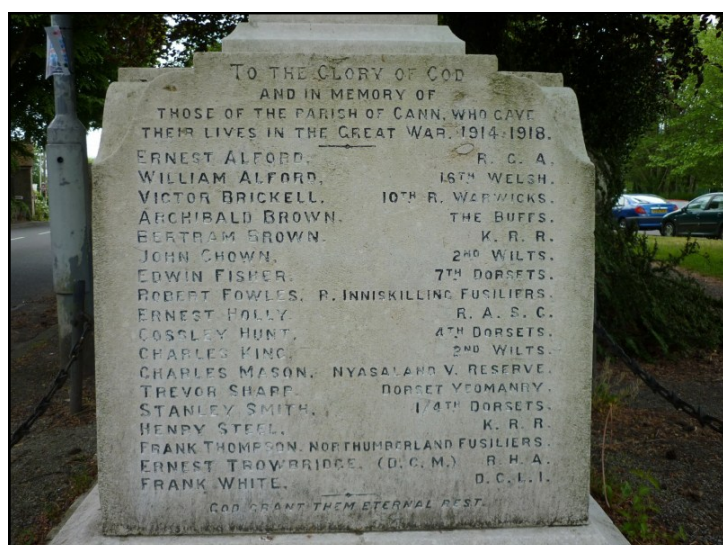
Cann war memorial, Dorset, WMO76631
© Chris Moreton 2011

- On a memorial in 'Fair' condition, lettering is on the whole well defined and legible, although there is a reduction in clarity, for example Cann war memorial in Dorset
- Lettering on a memorial in 'Poor' condition, like war memorial 1, is difficult to read due to reduced definition. There may also be ivy, moss, algae or lichen present and occasional missing letters

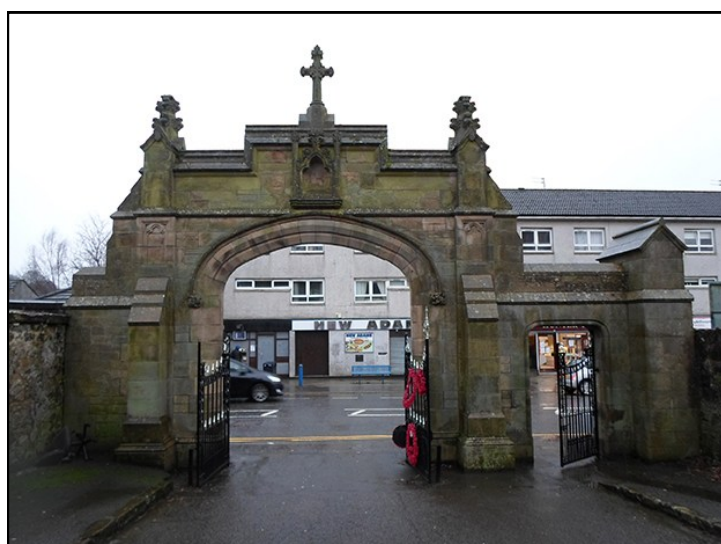
Campsie (Lennoxton) war memorial, Dumbartonshire, WMO165084 © War Memorials Trust 2014

- Memorials with stone elements that are in 'Fair' condition like Campsie are stable and periodic maintenance is evident. There is minimal damage/deterioration/discolouration
- War memorial 2 is in 'Poor' condition because although the structure is stable, the materials are damaged and repairs are needed

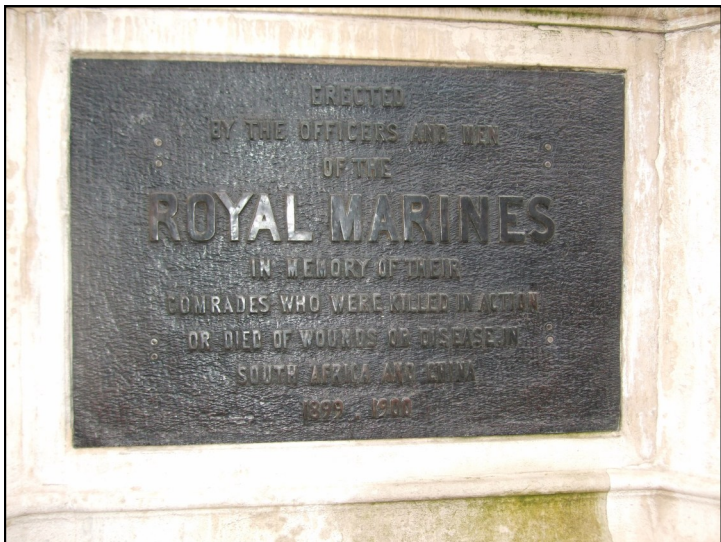
Royal Marines South Africa and China war memorial,
London, WMO112036 © War Memorials Trust 2013

- Metal elements of memorials that are in 'Fair' condition, such as the Royal Marines South Africa and China war memorial, are stable and firmly attached to surface
- They may require some maintenance
- Inscriptions are legible, but there may be some loss in definition
- Memorial 3 is in 'Poor' condition because the plaque is corroded (metal corrosion would normally appear as orange for iron and blue/green for bronze, brass and copper)
- The memorial is also dented and requires repair
- Inscriptions are becoming obscured by discoloration
- Materials are stable, but there may be access restrictions or issues with displaying the memorial

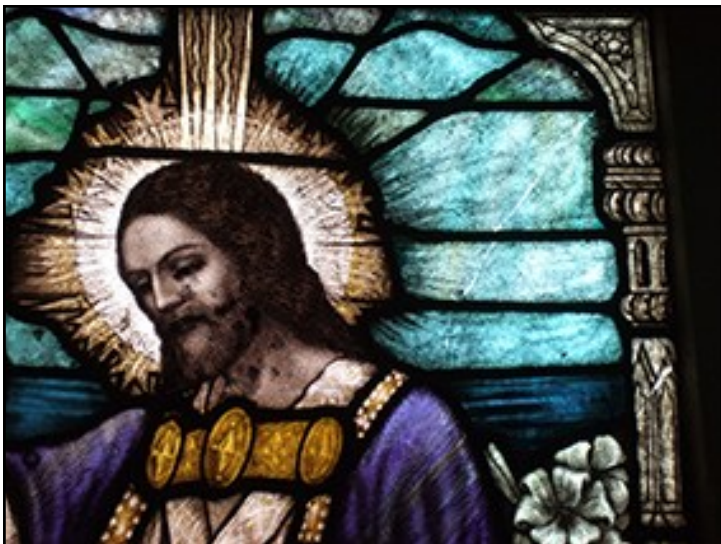
Malmesbury war memorial, Wiltshire,
WMO130671 © Richard Payler 2012

- Malmesbury war memorial window is in 'Fair' condition because the memorial is secure and maintained but may be in need of minor repair works to the small crack
- Leading is generally complete, but may require monitoring or maintenance
- Support or guards on the window do not detract from the design of the memorial
- Memorial 4 is in 'Poor' condition because the lead canes are deteriorating causing the window to bow
- Additionally the stained glass itself is damaged and requires repair
- Surrounding mortar may be damaged, or inappropriate (for example cement)
- Lettering is difficult to read due to damage to the surface of the glass

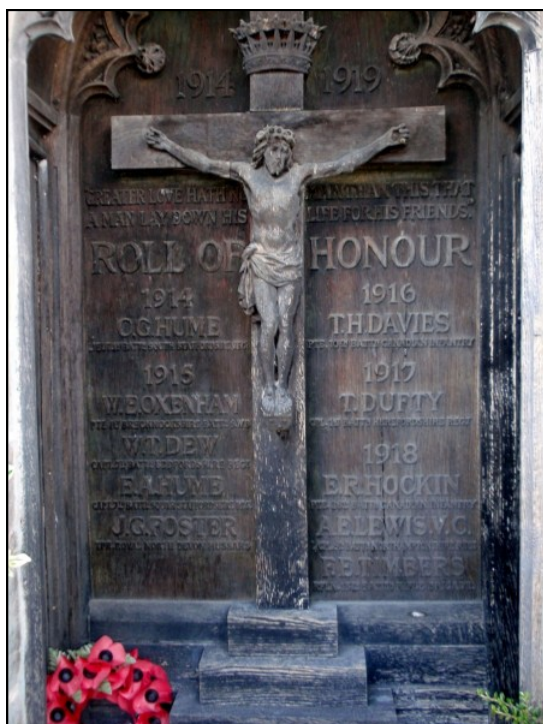
Whitney war memorial, Herefordshire,
WMO182529 © Steve Morgan 2014

- Memorials with timber elements that are in 'Fair' condition, like Whitney, may require some maintenance, but lettering is readable and materials are stable with minimal damage
- Any paintwork is generally complete but may require monitoring or maintenance
- Memorial 4 is in 'Poor' condition because although the materials are stable, they are in need of repair, and the inscriptions are becoming obscured by damage to the surface of the timber
- Timber may be suffering from rot or infestation
