How to identify condition

WAR MEMORIALS ONLINE

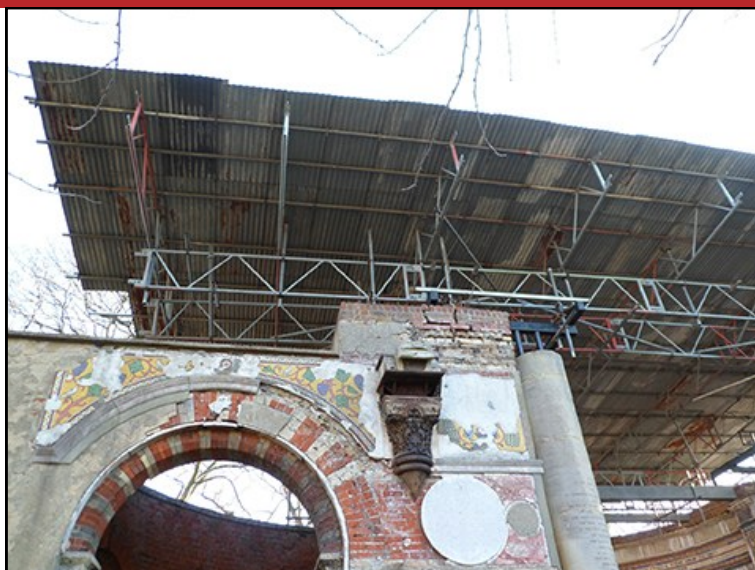
War Memorial 1 is unstable and there is significant damage to the materials © WMT, 2012

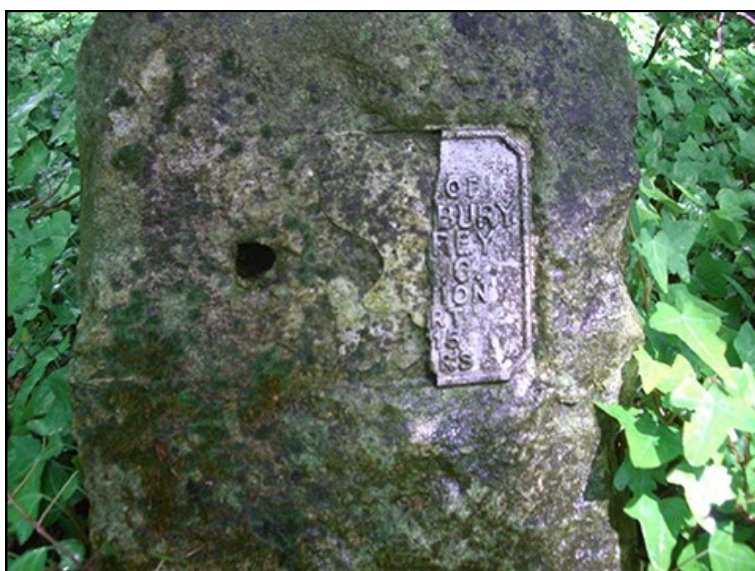
War Memorial 2 has a damaged plaque which is half missing © Angela van der Horst, 2014

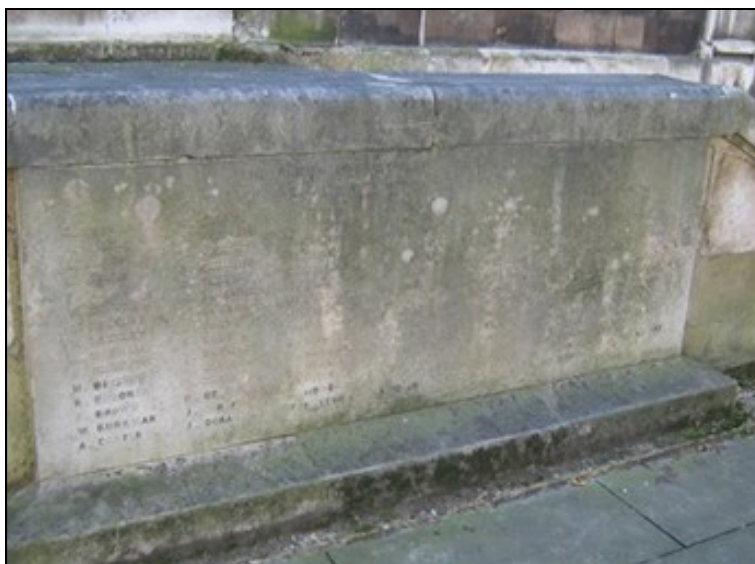
War Memorial 3's lettering is illegible © WMT, 2010

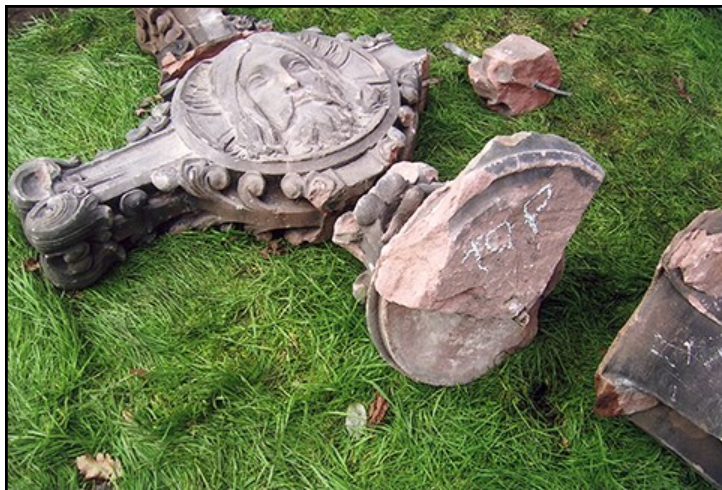
Kirkby war memorial, Merseyside, WM0108751
© Kings Regt Assoc Knowsley, 2005
